NAVORD REPORT 2932

INVESTIGATION OF MARK 18 TORPEDO FAILURES

25 AUGUST 1953

By:
Richard H. Stresau
L. E. Starr

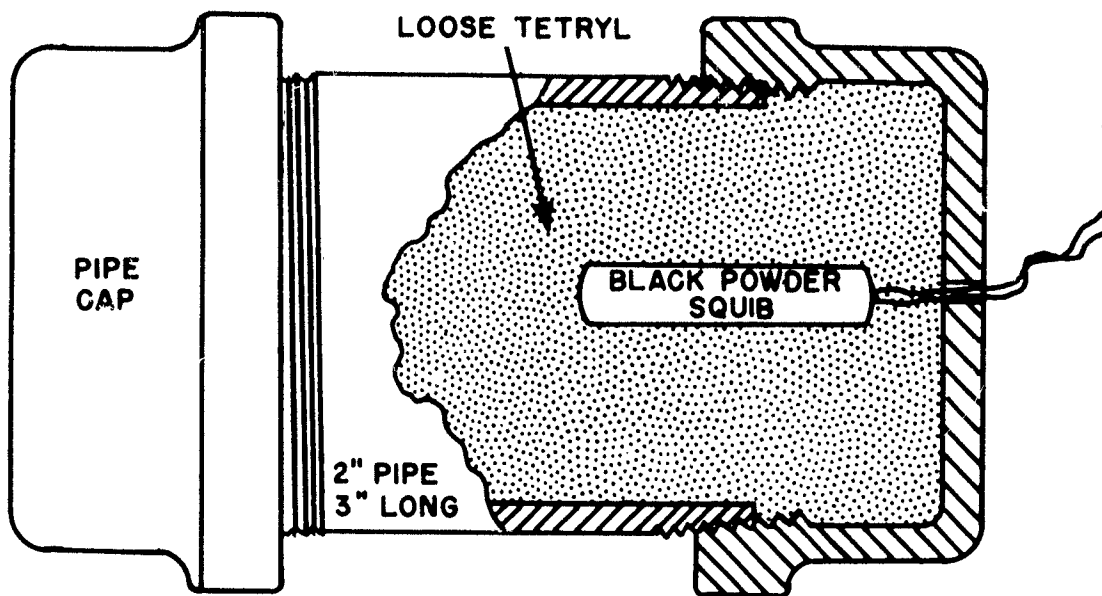
FIG.2 LOOSE TETRYL CONFINEMENT TEST

12. When confined in the paint cans, the tetryl only reacted vigorously enough to open the can. Under the higher confinement of the pipe nipple, however, the action was much more violent than that which would result from a pressure sufficient to merely burst the pipe. The pipe was broken into fragments about the size of a quarter and the dent produced in a steel plate upon which the assembly rested was of the order of magnitude of that which the detonation of an equivalent quantity of tetryl might produce.

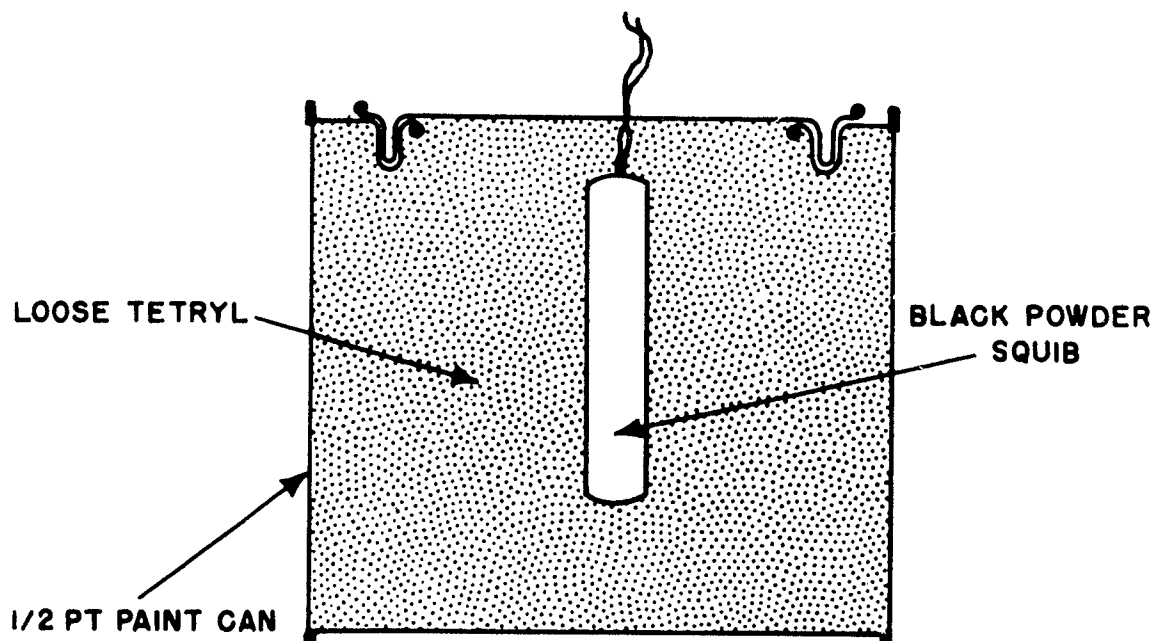
FIG.3 LOOSE TETRYL CONFINEMENT TEST

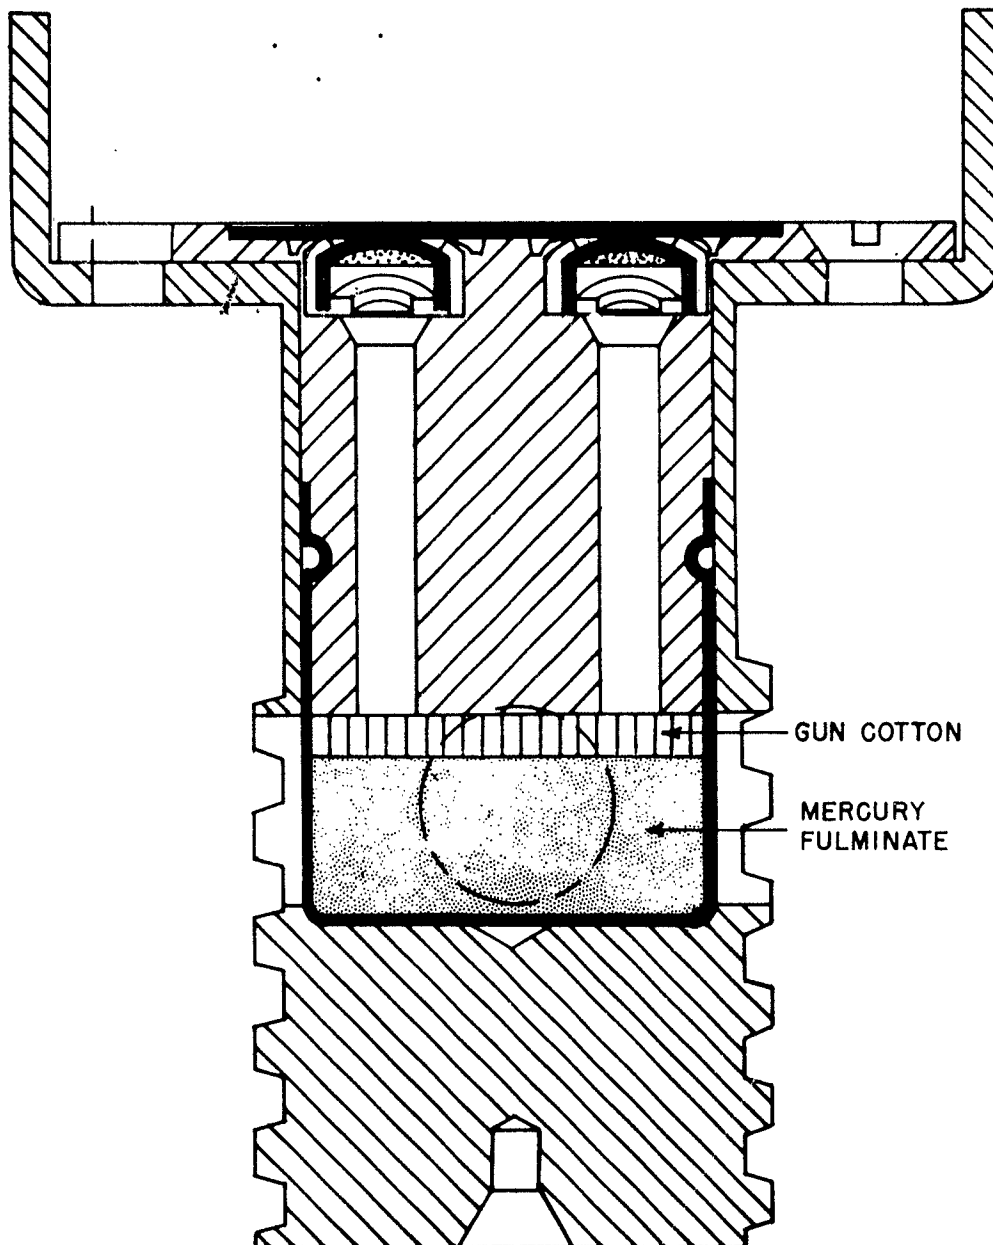
FIG. 7
DETONATOR MK 8 MOD 3

19. It will be noted that of the total of 66 trials all 13 low order actions occurred when Mk 8 Mod 3 base charges were used. The probability of this occurring as the result of chance distribution of systems prone to failure for a reason other than detonator trouble, such as faulty boosters, for example, is only one in 20,000. The fact that 8 high order detonations occurred in 8 trials with the XE-12A detonators, Figure 10, which contain only about one fifteenth as much explosive as the Mk 8 detonators is an indication that the low orders were caused by a difference in kind of reaction of the detonator rather than merely a difference in degree.

20. It will be noted that the use of the new Mk 126 primer resulted in no significant improvement when the Mk 8 Mod 3 base charge was used and that the Mk 8 Mod 4 base charge gave nine high orders in nine trials when used with the old Winchester #3 primers. It would appear that the primers are not involved in failures of this type. This is not to say that the change in primers is unnecessary, but it is believed that primer failure would result in no action of the base charge rather than in low order action.

(1) All Mk 8 Mod 3 detonators be replaced by Mk 8 Mod 4 detonators.

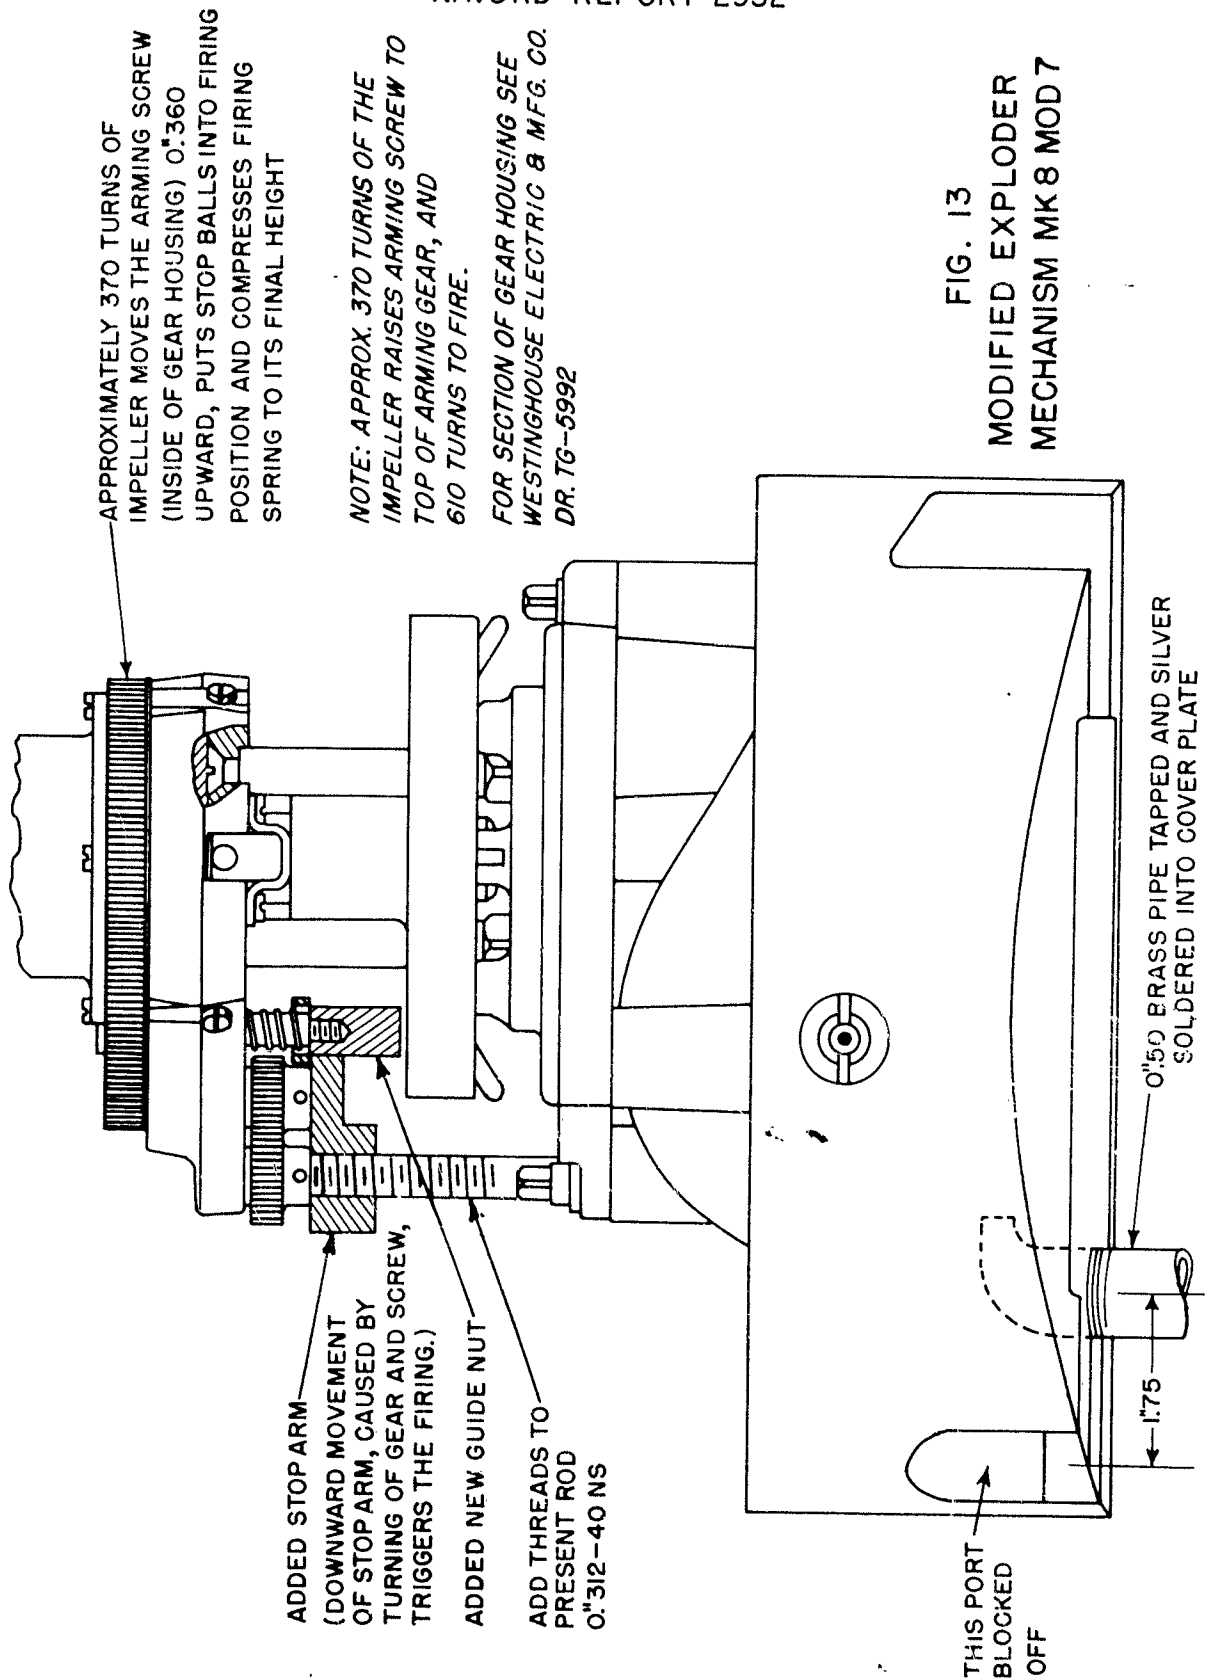
FIG. 13
MODIFIED EXPLODER
MECHANISM MK 8 MOD 7

25. A group of exploders, Mk 8 Mod 7, were modified as shown in Figure 13, and in more detail in reference (d), for use by the Naval Proving Ground, Dahlgren, Virginia, in fully loaded warheads. The modifications made it possible to arm and fire the exploders by means of water conducted to the mechanism by a hose. The water was pumped by means of a fire engine through about 1,000 feet of fire hose and 50 feet of garden hose. The garden hose was used for the last 50 feet because it was considered to be more expendible. The warheads were set up as shown in Figures 14 and 15 so that in case of a failure, the exploder could be removed from a distance by pulling the rope.

26. The pressure drop in the garden hose was such that only five of the ten exploder mechanisms would operate satisfactorily. Some of the mechanisms were so stiff that it is doubted that they would work in service.

27. After adjusting and lubricating the exploders and installing the nozzles shown in dotted lines on Figure 13, four of the remaining five exploders were made to operate satisfactorily.
